LIMITED ASBESTOS INSPECTION

St. Bernard Port – Buildings 172 and 172A
100 Port Boulevard
Chalmette, Louisiana

Prepared on:
May 12, 2020

SEMS Project #1134-0007

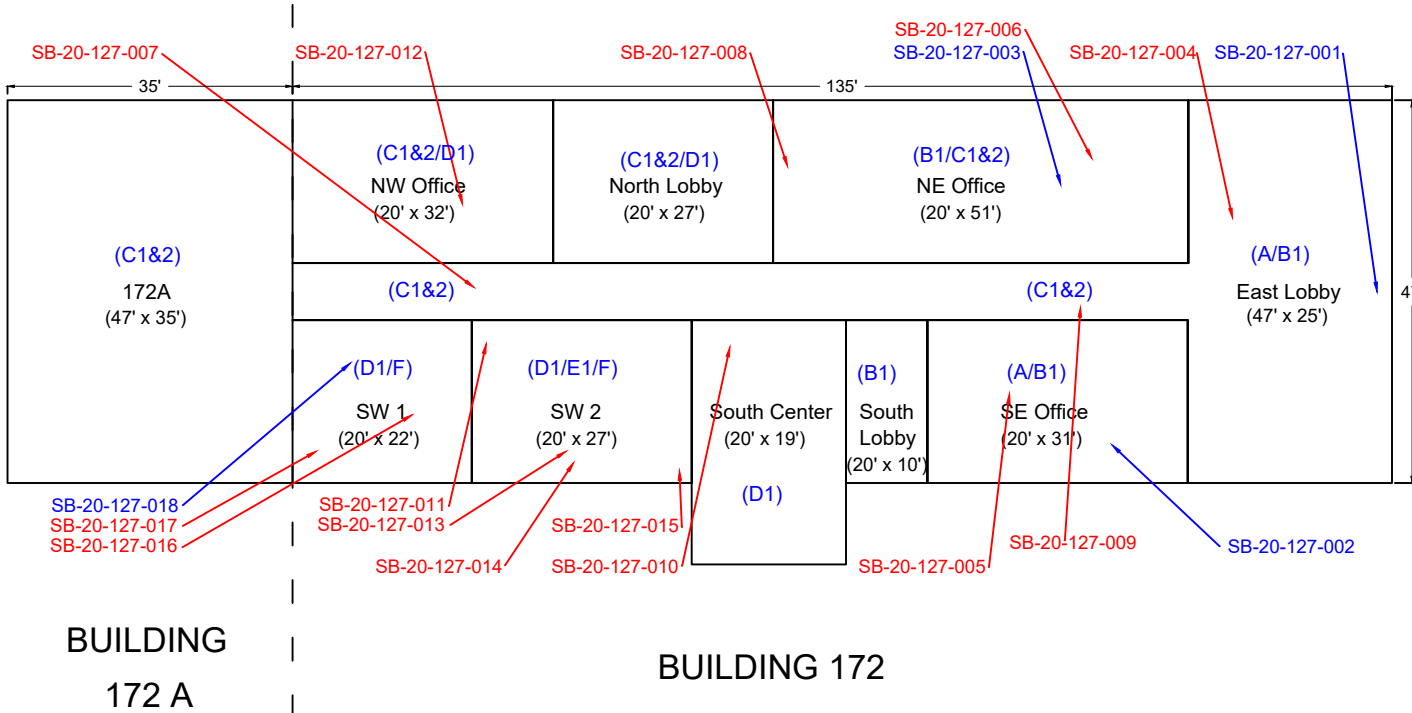
FLOORING SAMPLES

Abatement in the South Center Office is not advised due to the collapse of the North Wall, as well as the frame bending near the ceiling. Flooring B1 and D1 are in a grid pattern in rooms: NW Office, North Lobby, NE Office, SW 1, and SW 2. They do not cover the entire floor, only one or two rows per office

- **Floor Tile & Mastic:** The floor tile and mastic are Category I non-friable Asbestos-Containing Materials. The floor tile and mastic would need to be removed by a licensed abatement contractor before any renovation or demolition activities occur. This will allow the concrete slab to be recycled or reused.

- **Linoleum:** The linoleum is a non-friable Asbestos-Containing Material. This material will have to be removed by a licensed abatement contractor before any renovation or demolition activities occur. This will allow the concrete slab to be recycled or reused.

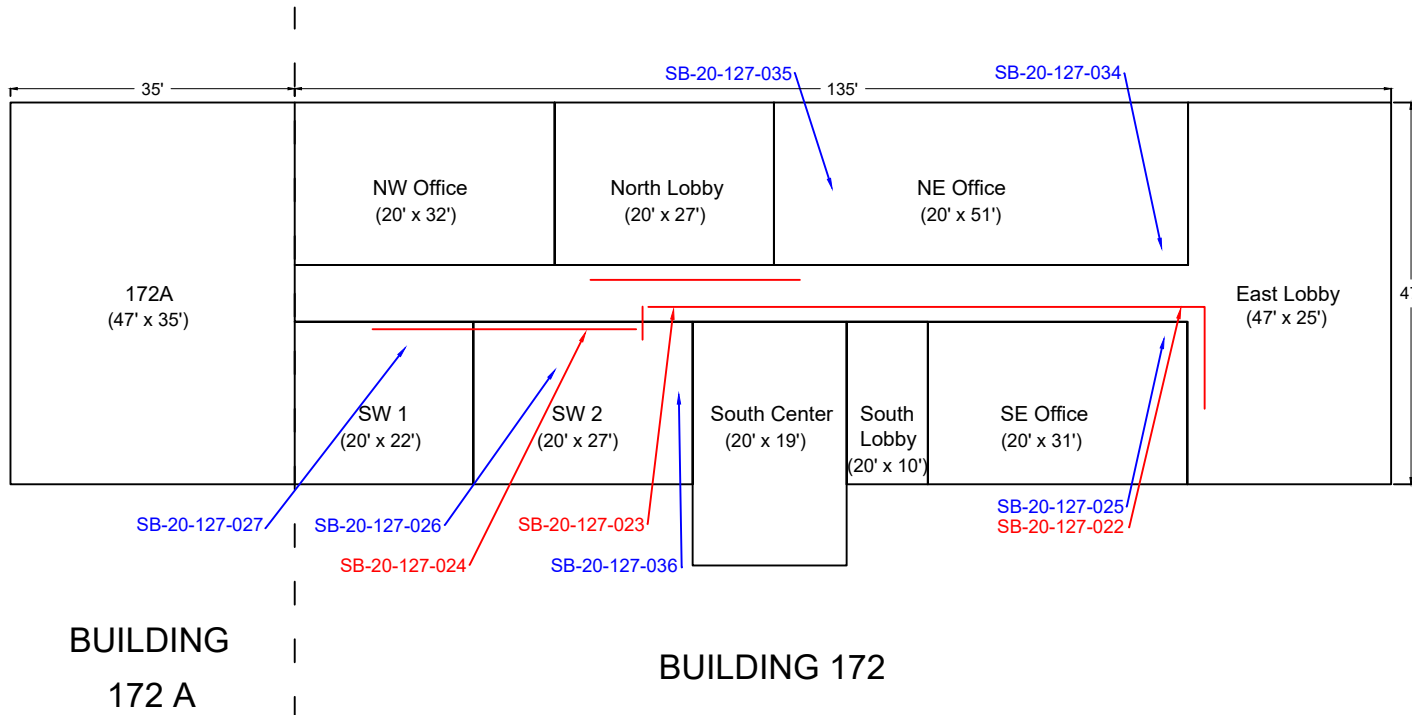
PIPING SAMPLES

— Approximately 150 linear feet of piping from which samples 022-024 were taken. Yellow piping insulation follows the same run.

- **Thermal System Insulation:** The thermal system insulation is a friable Asbestos-Containing Material. This material will have to be removed by a licensed abatement contractor before any renovation or demolition activities occur. The pipe insulation will need to be glove bagged and removed prior to renovation or demolition activities.

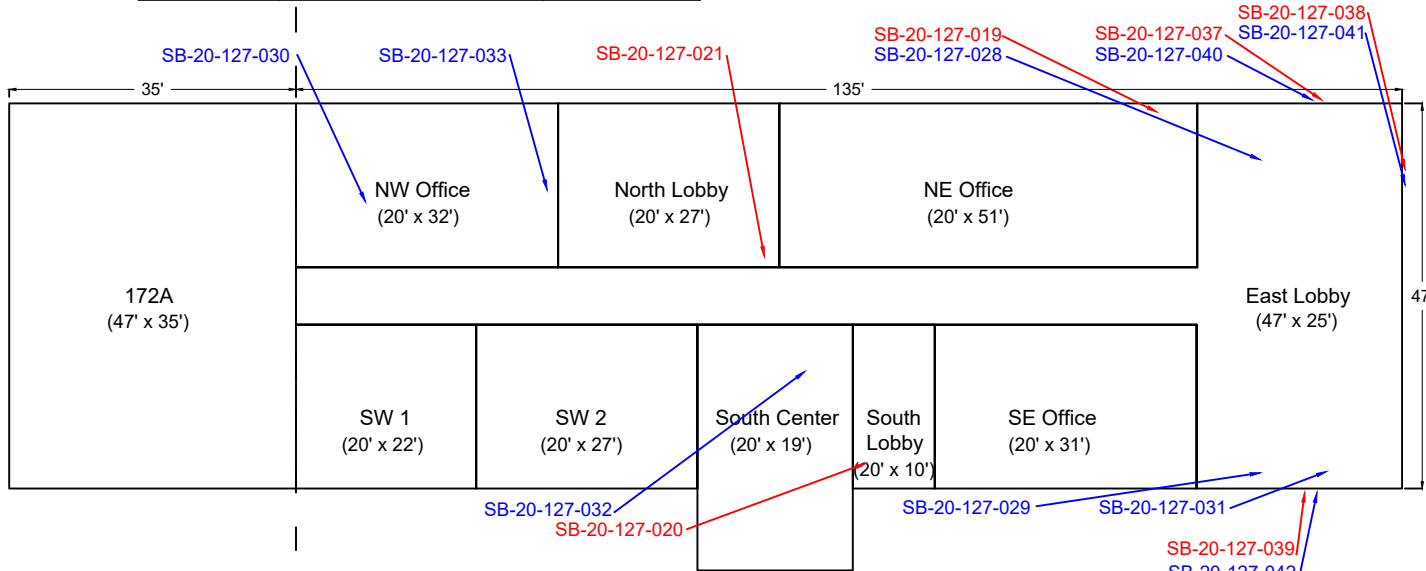
MISCELLANEOUS SAMPLES

Small pieces of drywall and compound are scattered throughout the building. Building has had flooding and over 90% of drywall is gone.

- **Texture Material and Joint Compound (MUD):** The texture material and joint compound are Category I non-friable Asbestos-Containing Materials. This material will have to be removed by a licensed abatement contractor before any renovation or demolition activities occur. Ninety (90) percent of the sheetrock has been removed previously, however the entire building will need to be cleaned and the sheetrock remnants will need to be removed.

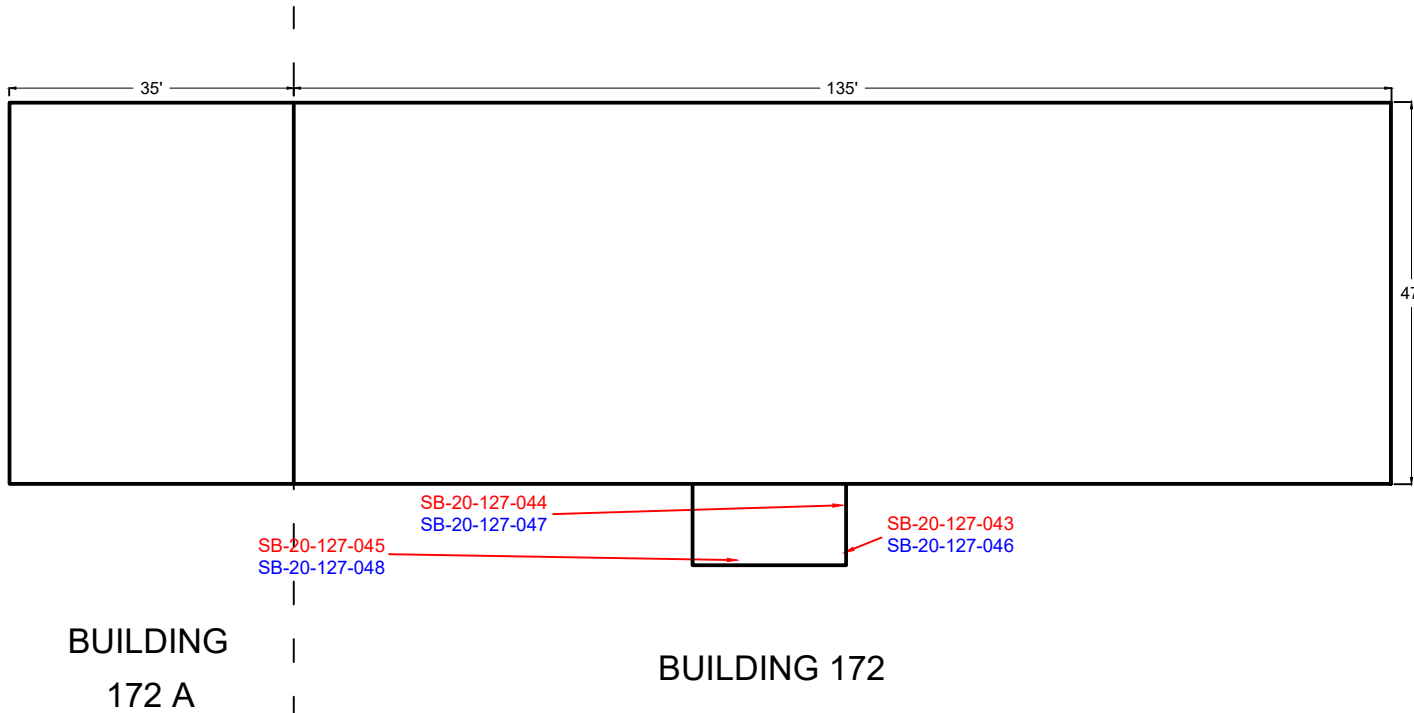
ROOFING SAMPLES

Parapet Wall is 20" tall by 12" wide. The southern portion of wall was the only area accessed due to the roof wall of the South Center Office had caved in with frame bending inside. Removal of the roofing mastic will have to be done as part of the demolition.

- **Roofing Tar:** The roofing tar is a non-friable asphaltic-based material. This material can be removed by a roofing contractor or asbestos contractor before any renovation activities occur. This material will need to be removed with the demolition debris during the demolition process. The roof

is not structurally sound and the roofing tar on the parapet wall cannot be safely removed prior to demolition.
